Customer: -----	Order Number: -----
Tool for Evaluation: Lower punch core rod tools	Method of Evaluation: Visual/Metallographic
Material: DC-53	Tool Hardness: 63.2 HRC (+/- 0.2)HRC
Lab Report #: -----	Date: 2/18/2013

----- returned several lower punch core rod tools that fractured during production, to Natoli for evaluation

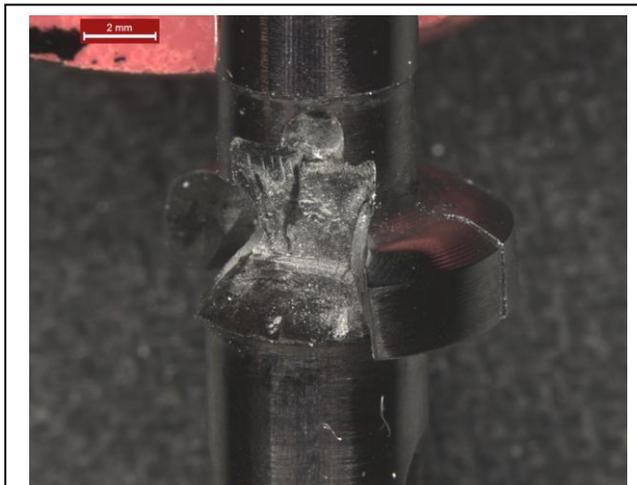
Examination of the lower punches that were still intact or partially intact showed multiple fractures to the shoulder (Figure 1) that extended along the lower radius and up through the shoulder to the top. This allowed the shoulder to break away from the punch in pieces. One section of shoulder (Figure 2) exhibited a well worn area that was not seen on the other pieces.

Figure 1 Lower punch core rod tool with fractured shoulder

Lower punch core rod tools failed due to cracks initiating at the lower shoulder radius, where the radius acted as a stress concentrator. The microstructure of the material at this location contained no defects with hardness that was more than adequate to resist yielding and could be lowered to help improve toughness/resistance to cracking.

Increasing the radius transition from the punch to the shoulder would lower the stress concentration at that critical location.

Reducing the material hardness would improve steel toughness and reduce the impact of stress concentrators.

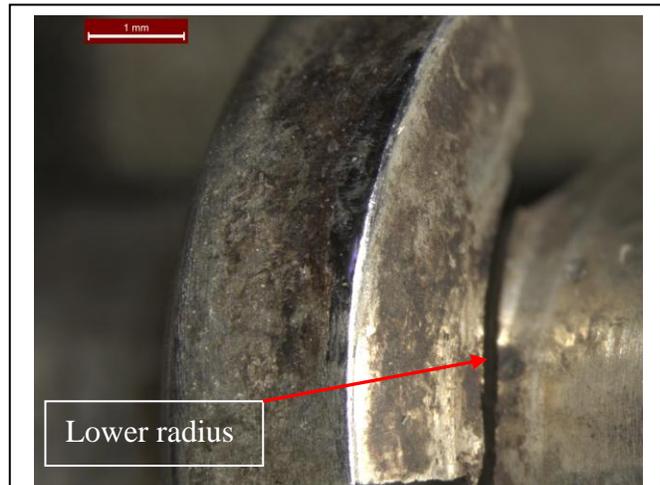
Figure 2 only observed section of shoulder with indication of wear

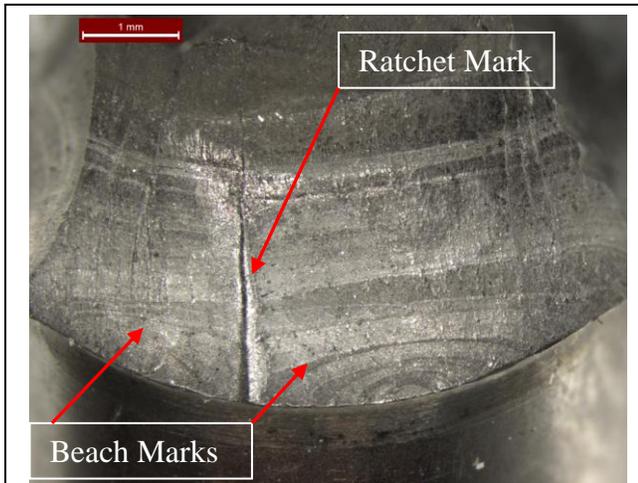
Beach marks (Figure 3) on the lower punch's fractured surface indicated that initiation occurred along the lower radius between the stem or body of the punch and the shoulder. The punches showed several origins of fracture along the lower radius of the shoulder as witnessed by the ratchet marks. Beach marks identify the defects origin by propagating in ever widening semi circles from the initiation point, similar to the marks left on the beach by advancing water. The ratchet marks are where two different sets of beach marks or crack propagations collide and the plane of fracture changes leaving a distinct upright line. Several sets of beach marks and ratchet marks (Figure 4) are visible on the fractured punches.

Figure 3 beach marks visible with ratchet marks

Beach marks and ratchet marks on the fracture surface of the punch show multiple points of origin along the lower shoulder radius, which suggests that failure was more dependent on geometry of the part than material.

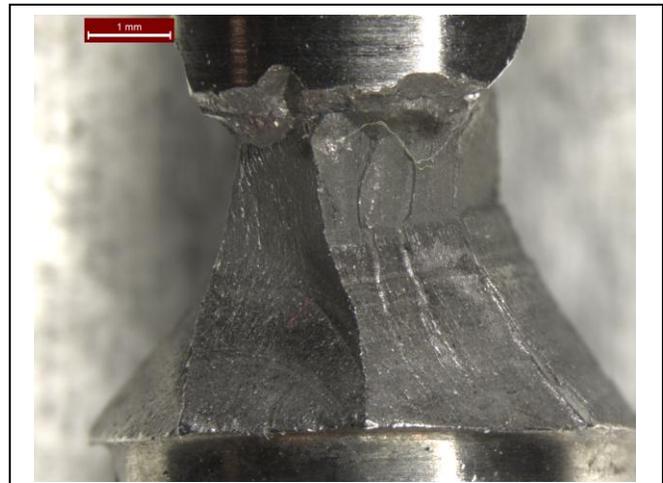
Figure 4 several sets of beach marks and ratchet marks

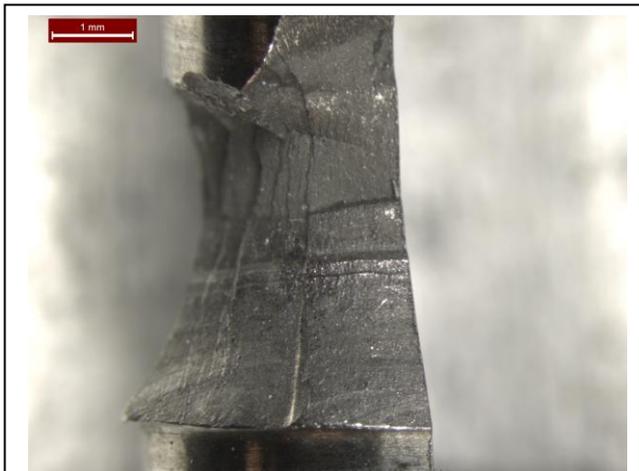
One punch was sectioned through the center of a beach mark (Figure 5) to help determine the source of failure. Metallographic examination of the lower radius was conducted in this area (Figure 6).

Figure 5 lower punch was sectioned through crack initiation

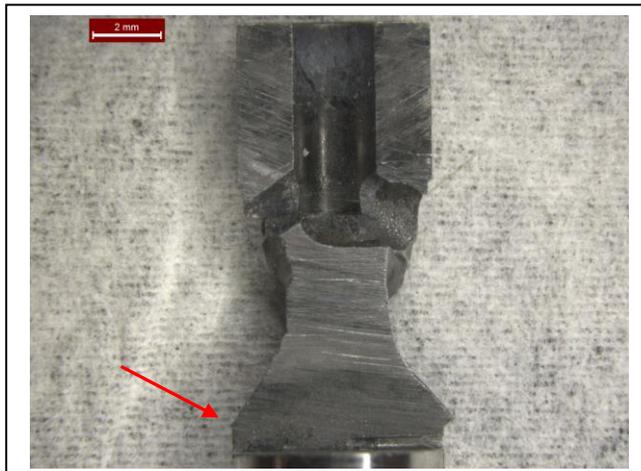
Figure 6 indicates area of micrograph

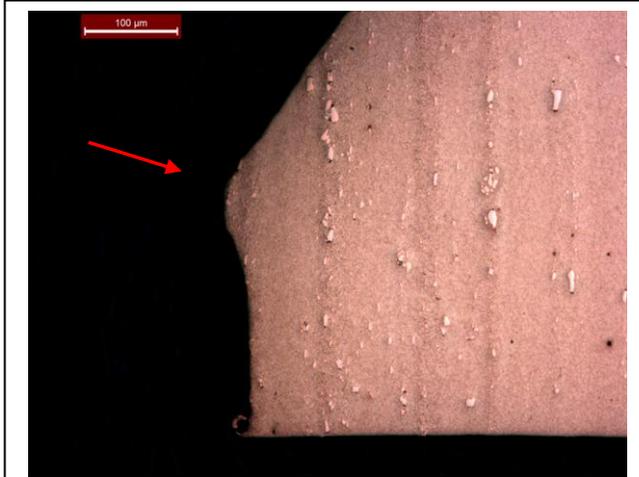
Metallurgical examination of the microstructure at the location of failure initiation showed a quenched and tempered martensitic microstructure with dispersed carbides, consistent with properly quenched and tempered DC53 steel. There was no indication of material defect.

Figure 7 Microstructure of lower shoulder radius 200X Etched with 3% Nital

Micro hardness measurements at the lower shoulder radius were 63.2 HRC (+/- 0.2) HRC.

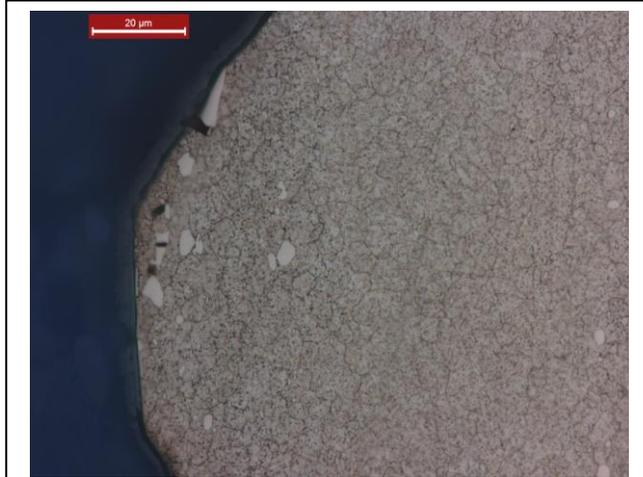
Figure 8 Microstructure of lower shoulder radius 1000X Etched with 3% Nital
